POST. Lab.
WATERTOWN ARSENAL
WATERTOWN, MASS.

REPORT NO. 710/197

A STUDY OF
THE MECHANISM OF PENETRATION OF HOMOGENEOUS
ARMOR PLATE

E. L. REED
Research Metallurgist

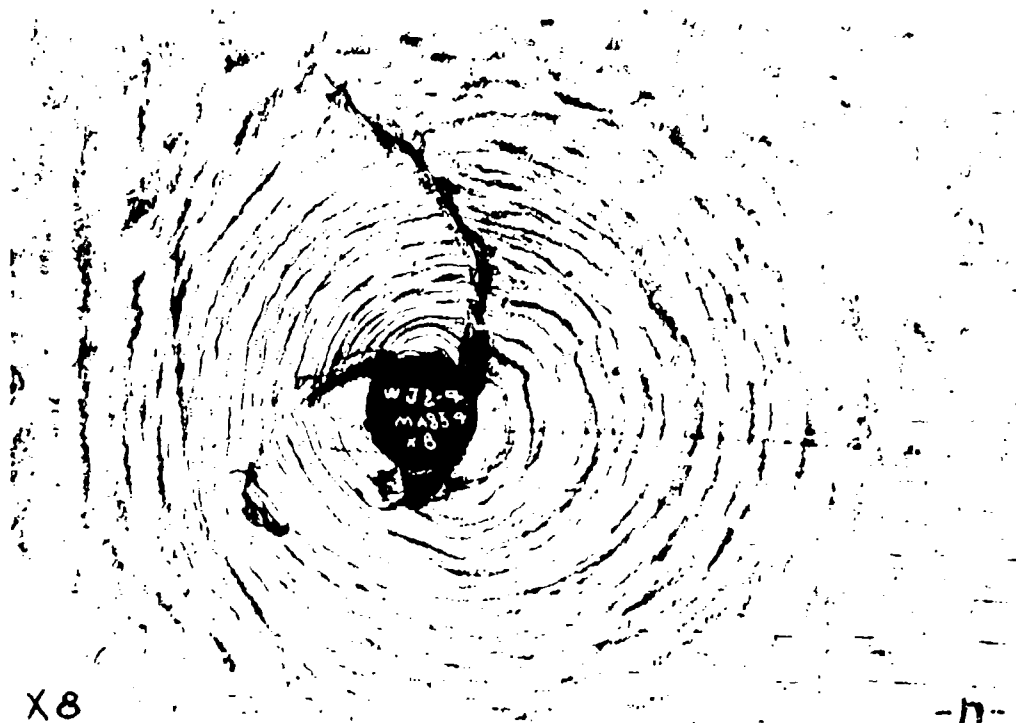
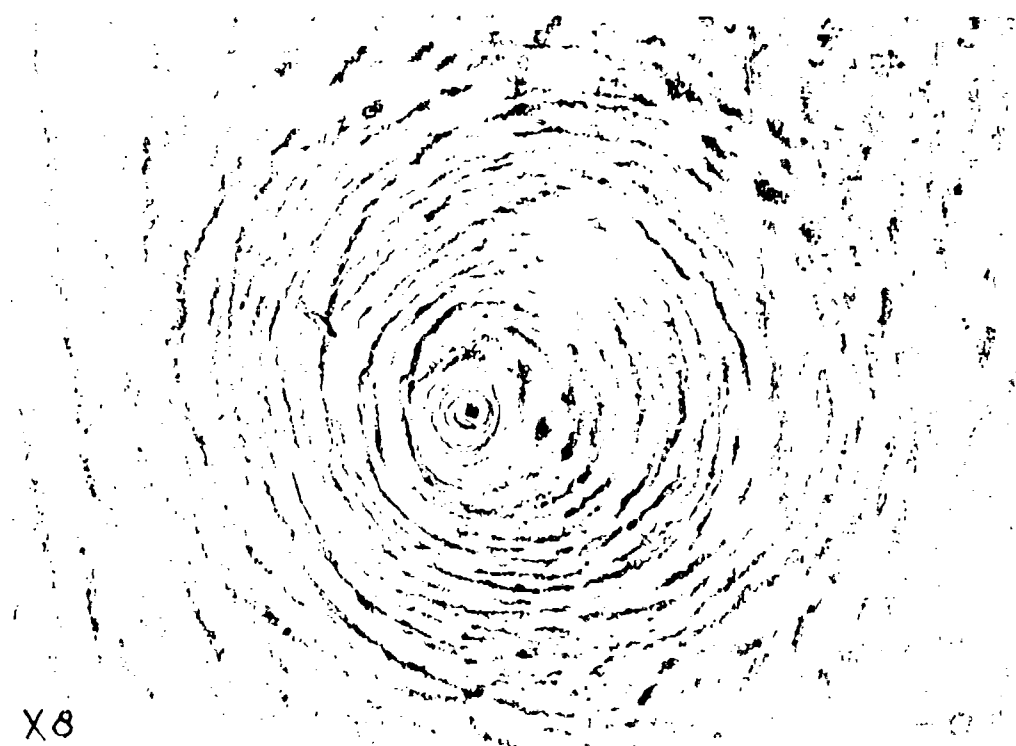
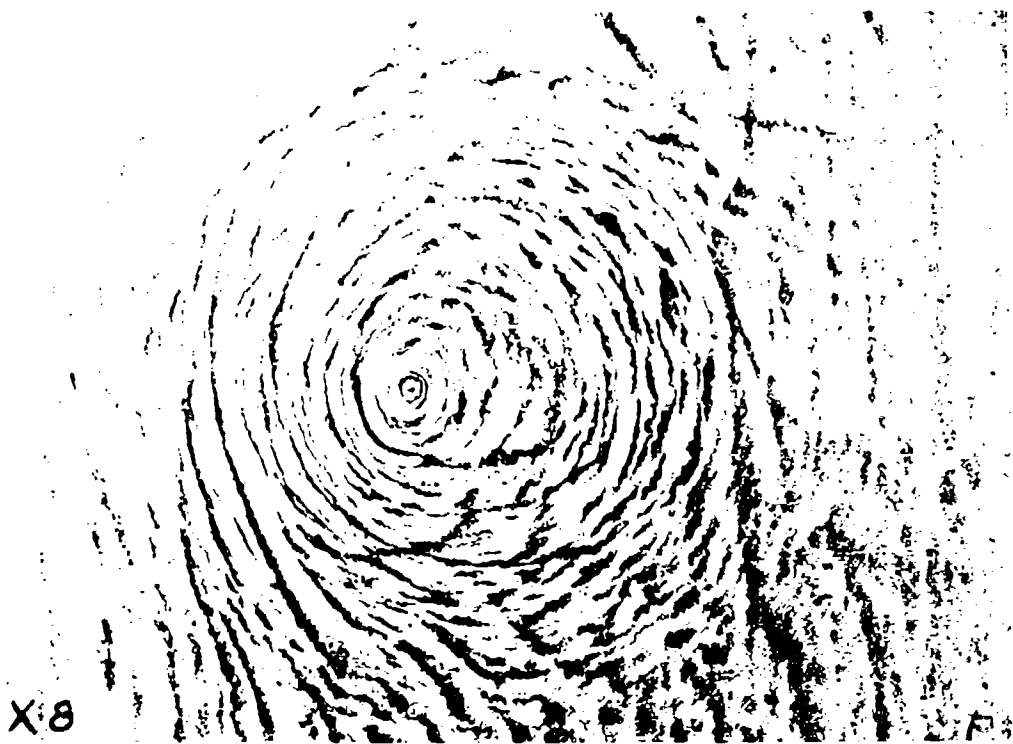
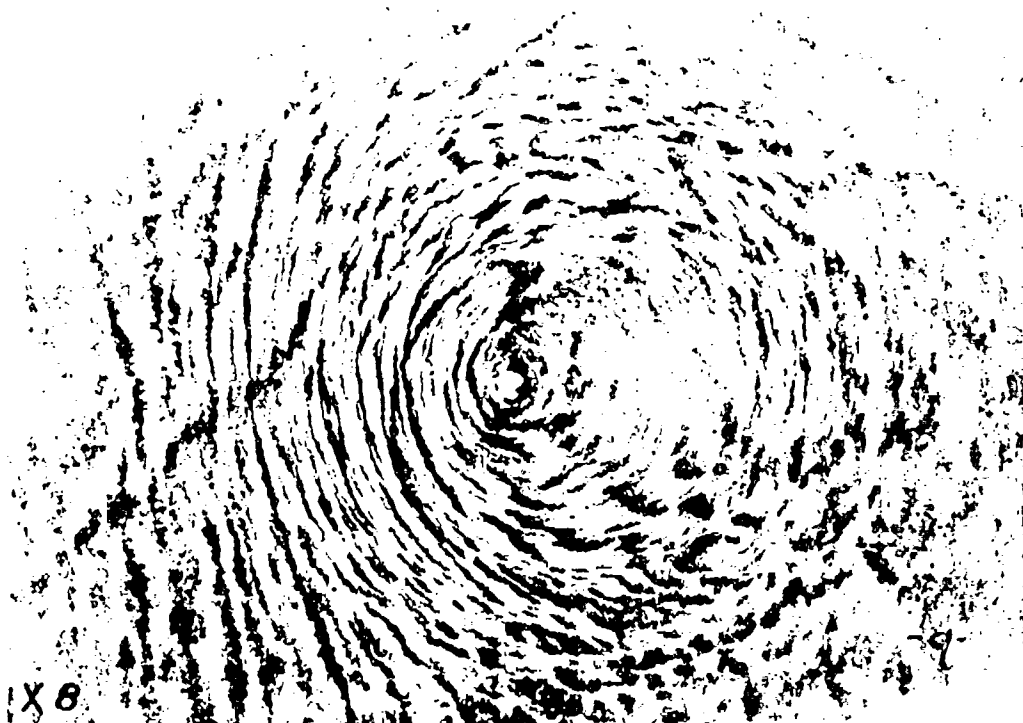
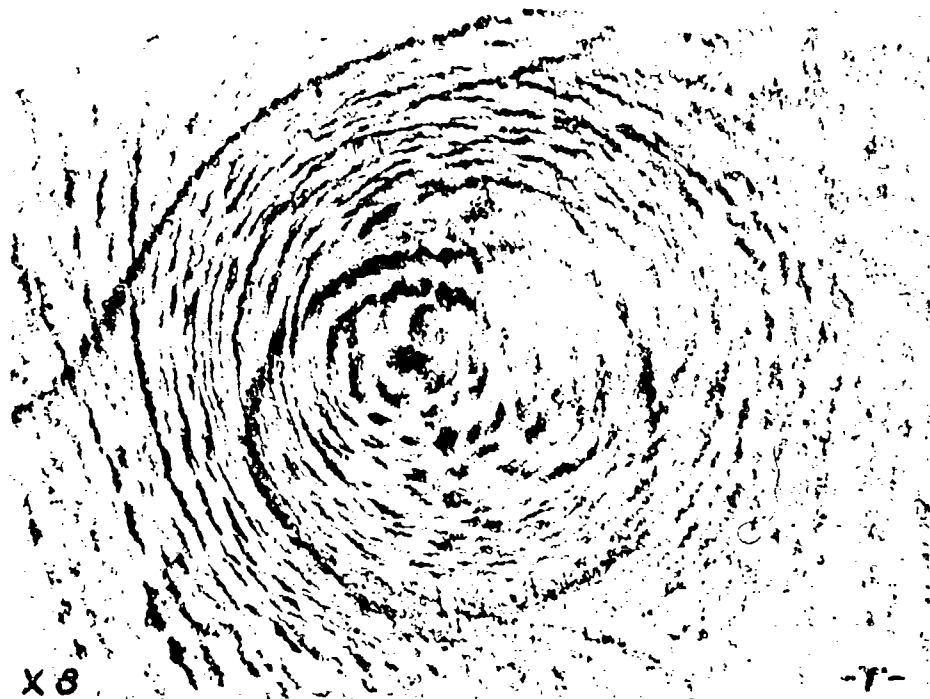
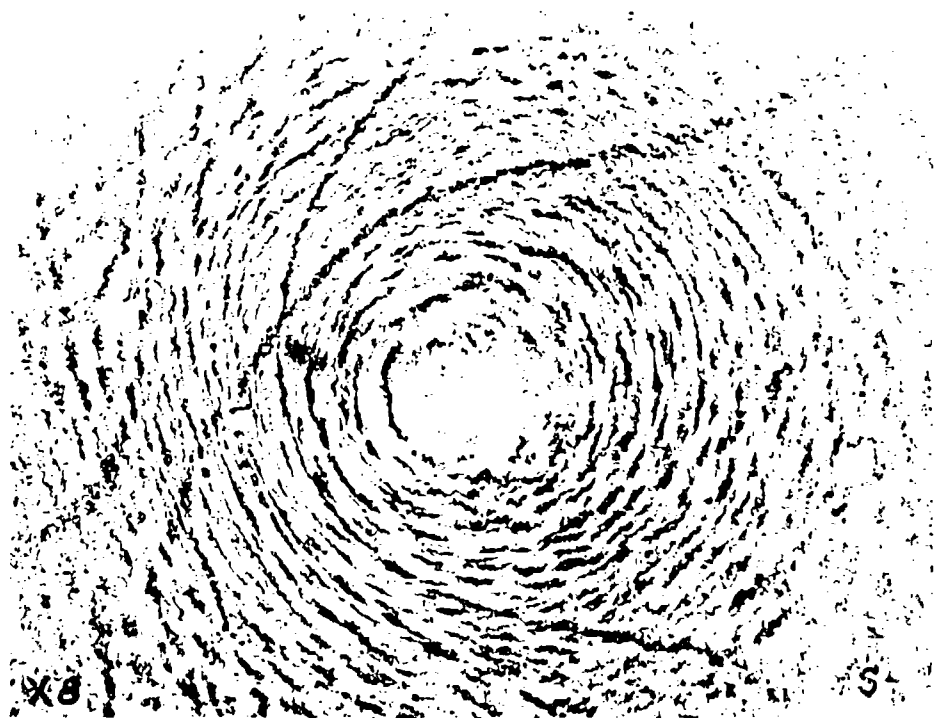
FIGURE 5.

In the case of the plate WJ2, -4, containing 3.58% nickel and 2.01% silicon, which was partially penetrated, particles of plate were blown off at the entrance end of the plate, and therefore no distortion was evident on the surface layers, see Figure 5 (a). At a depth of approximately .166 inch below the entrance face of the plate, the first evidence of torsional flow of the metal as revealed by the swirling effect of the dendritic segregation is evident. Near the exit side of the plate, there is a decrease in size of area distorted by bullet impact.

Heavy membranes of "white layer" were present near the bullet hole in the layers near the entrance face of the plate. The orientation of these layers varied considerably. Crack systems were promoted by the severe twisting of the metal during bullet penetration. This plate is particularly interesting due to the fact that dendritic segregation persisted throughout the entire plate and evidence of the marked rotational effect of the bullet was revealed by the swirl of the dendritic segregation.

Progressive changes in the macrostructure. Marked dendritic segregation persists throughout the layers as well as the torsional deformation caused by bullet spin.

- (l) Note crack forms at outer limit of swirl deformation. Corresponds to (c) above.

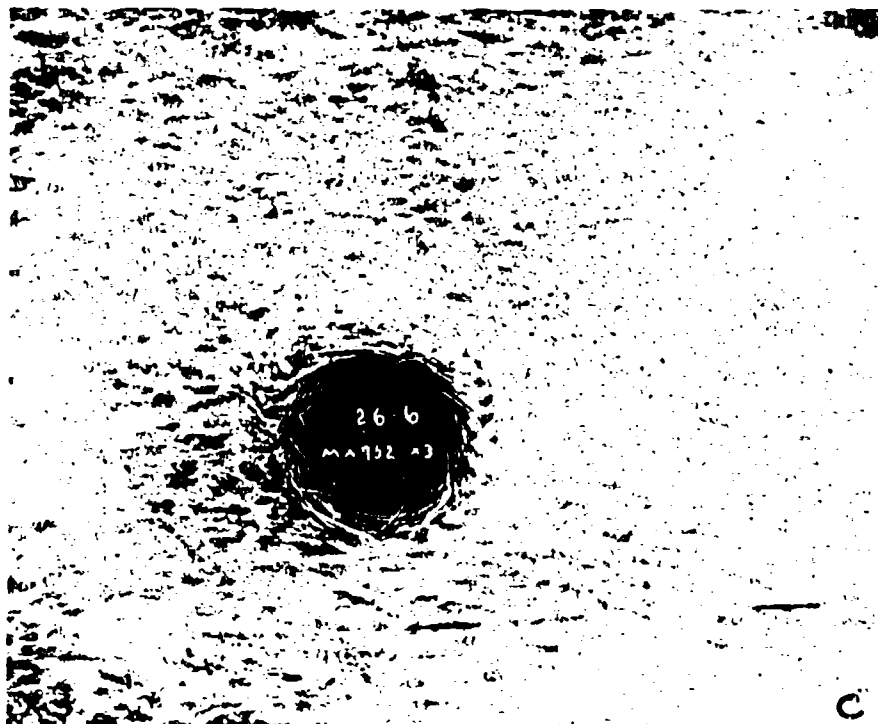
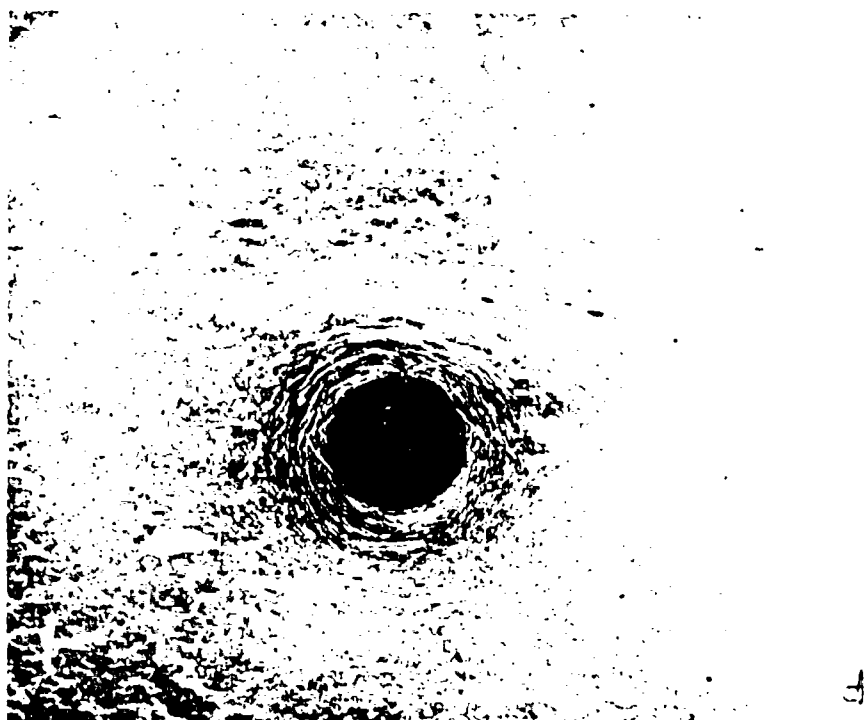
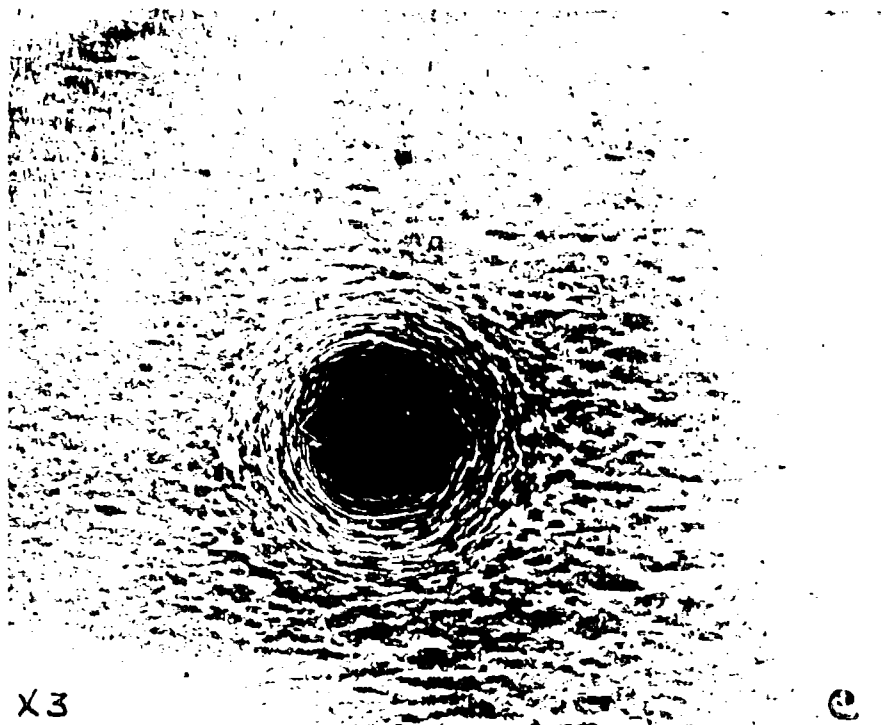
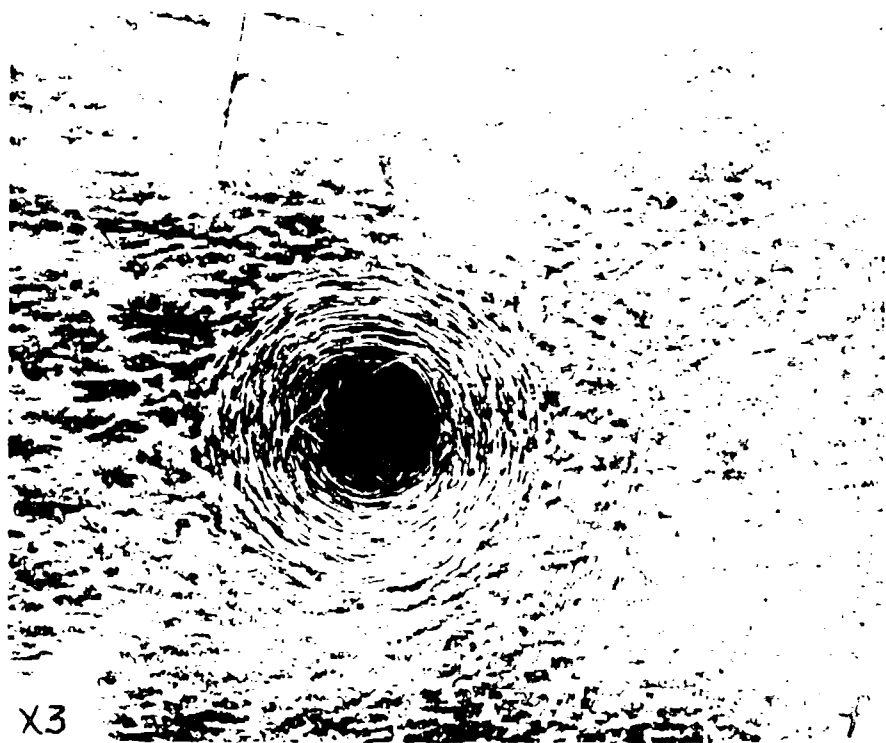
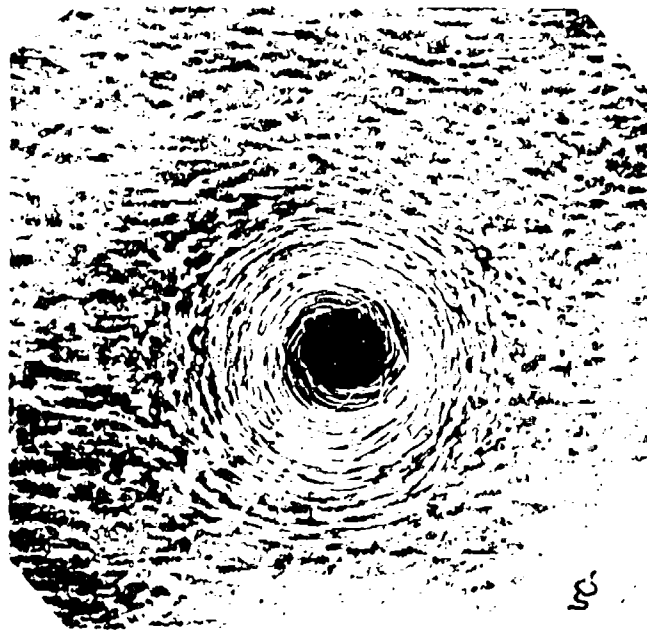
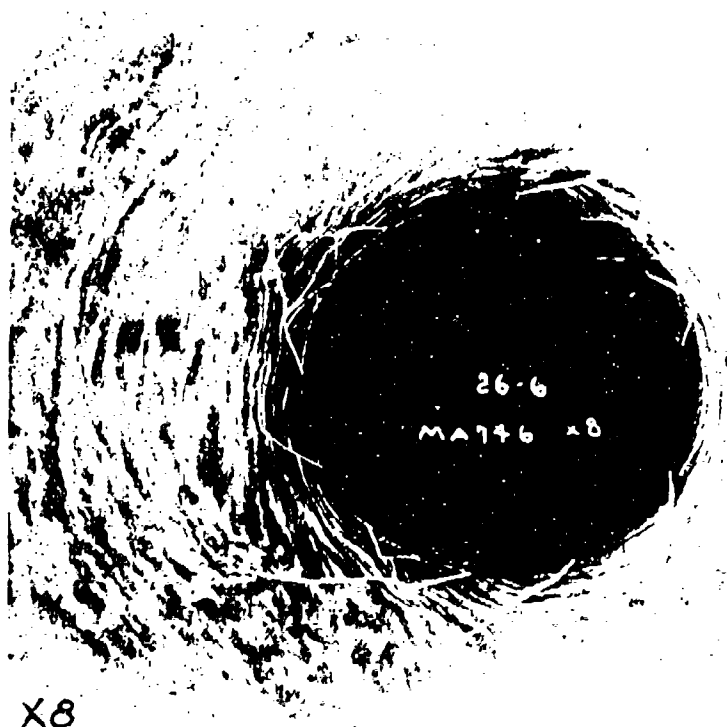
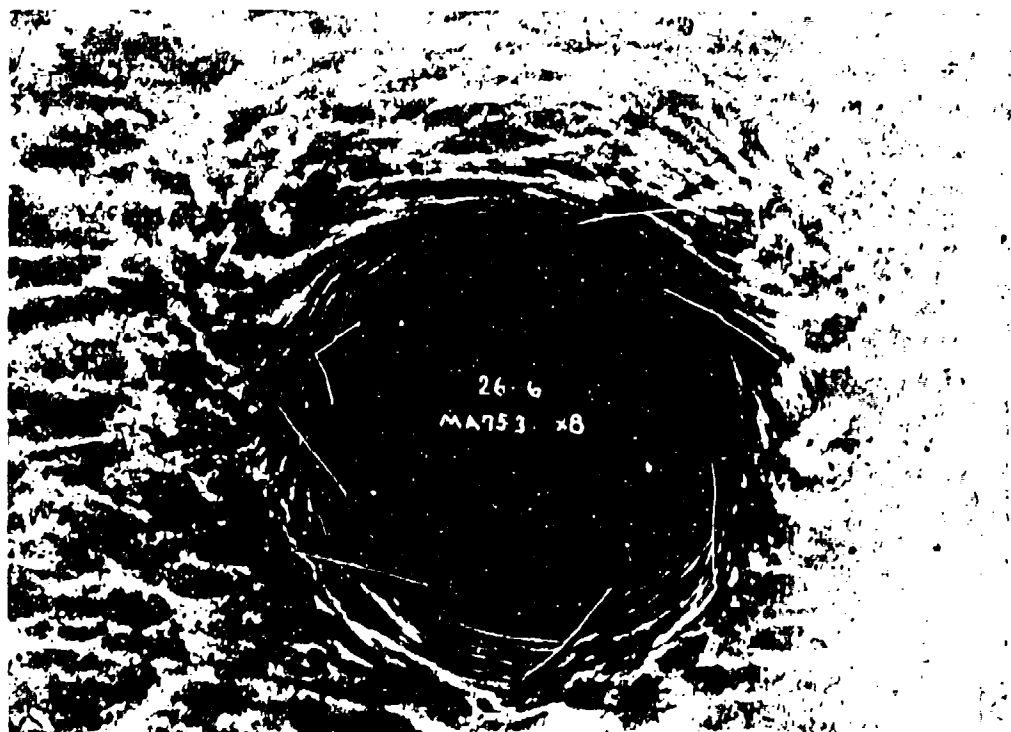
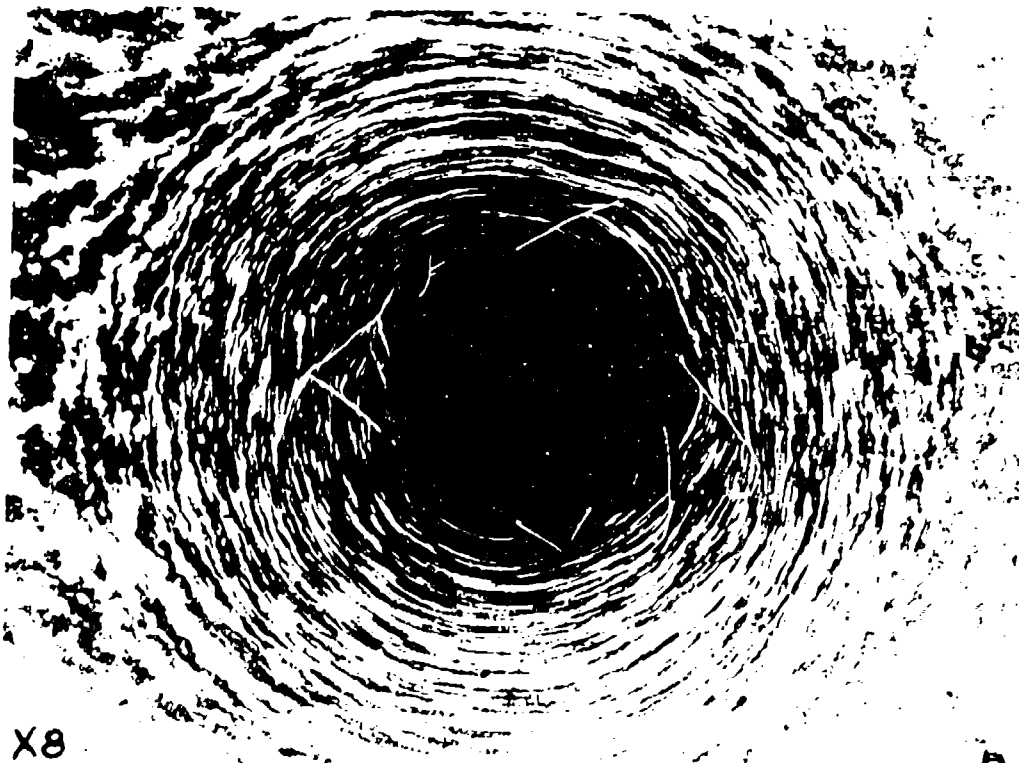
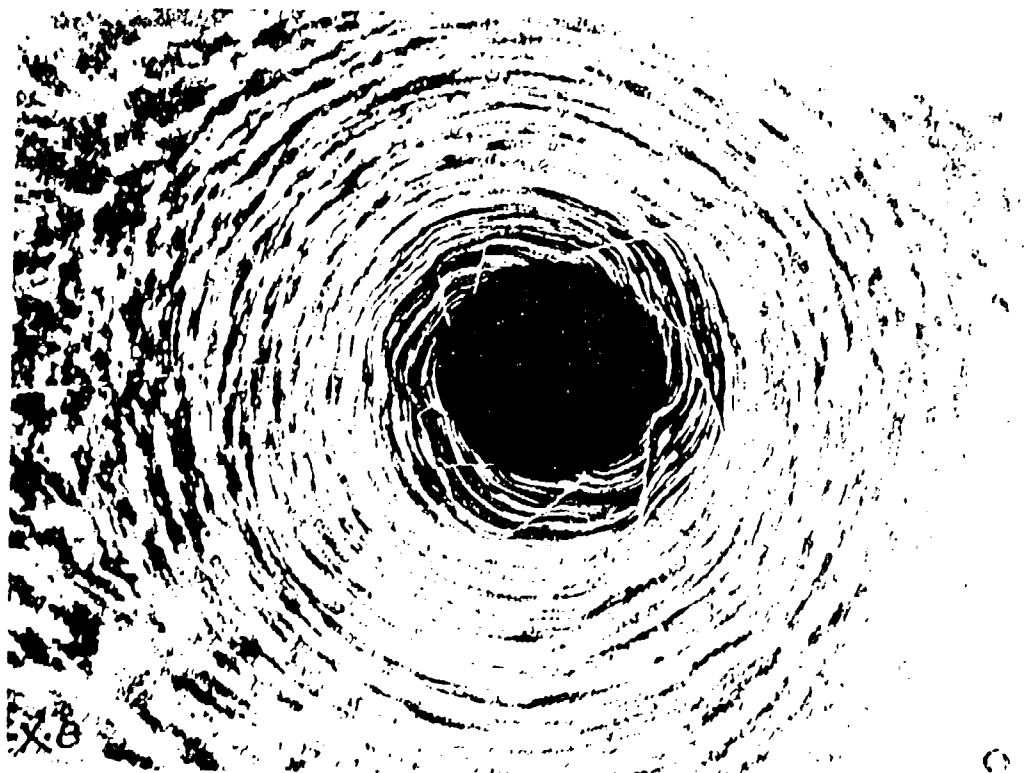
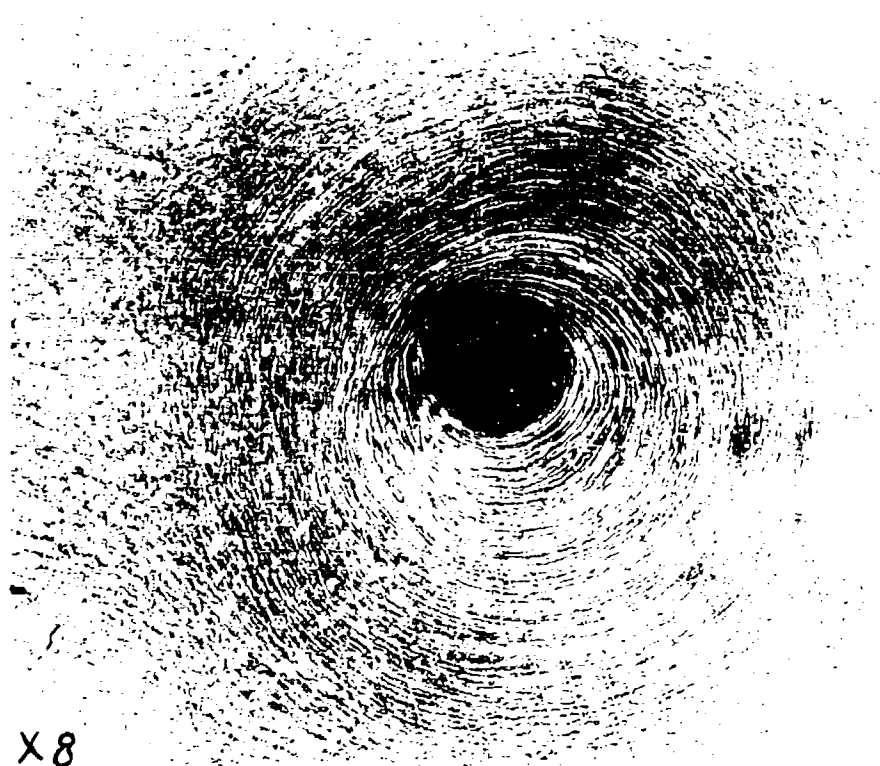
FIGURE 6

Consecutive layers through the surface show much the same sort of thing as Figure 5. However, the dendritic structure is almost negligible.

Figure 6 illustrates the progressive changes in macrostructures of area affected by bullet impact in a standard chromium-molybdenum-vanadium plate completely penetrated by a Cal .30 A.P. M1922 bullet.

A study of the macrostructures of this series indicates that "white layers" represent planes of greatest slip stress, oriented 30 to 45 degrees to direction of impact, and persist at the bullet hole. A circular swirl of deformed dendritic segregation as the result of the spinning of the bullet was clearly evident.

To confirm the opinion that the twisting of plate metal about the bullet hole was caused by the spin of the bullet, there is illustrated (Fig. 6 (q)) a punching impact made with ball ammunition. Due to the flattening of the lead immediately on striking, no spinning action was introduced into the plate, and true to predictions, no torsional flow could be found in this plate.

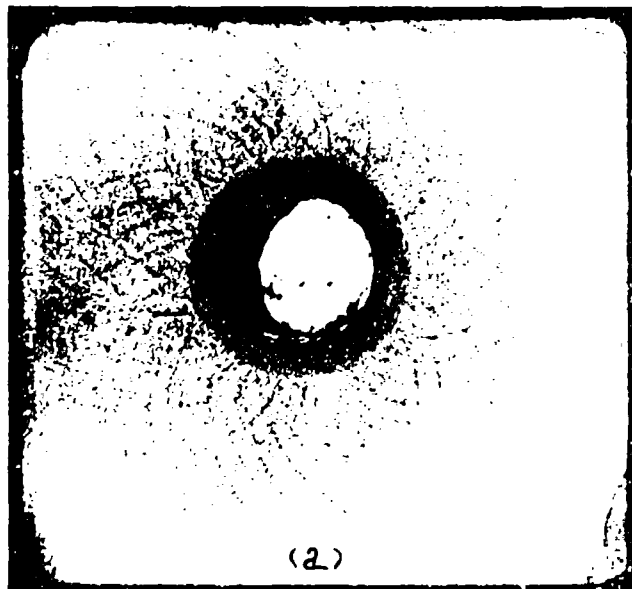
revealing strain in low and medium carbon steels, is not suitable for revealing strain in armor plate, due to the fact that no free ferrite persists in heat treated armor plate. There are inserted photographs, Figures 9 (a), (b), which illustrate clearly Lder lines on the front and back faces of a low carbon steel plate subjected to impact with Cal .30 ball ammunition at a striking velocity of 2600 f.s.

Fry's reagent after heating 45 minutes,
preheating at 200°C.
